I SINKHOLES. GLI SPROFONDAMENTI CATASTROFICI NELL'AMBIENTE NATURALE ED IN QUELLO ANTROPIZZATO

ACTIVITY OF THE ITALIAN NATIONAL RESEARCH COUNCIL IN THE AFTERMATH OF THE 6 APRIL 2009, ABRUZZO EARTHQUAKE: THE SINIZZO LAKE CASE STUDY

di Parise M.¹, Perrone A.², Violante C.³, Stewart J.P.⁴, Simonelli A.⁵ & Guzzetti F.^{1,6}

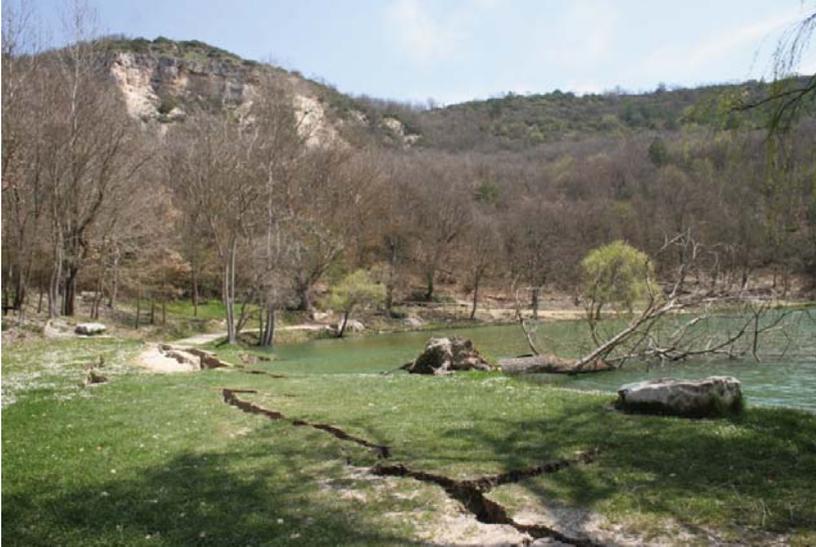
Fig. 3 – Overall view, looking SE, from the northern side of the lake: in the foreground, some of the cracks on the lake shores. Note in the background, in the upper left of the picture, the source areas of rock falls, that follow the strata attitude, affecting the same layer of conglomerate.

Lake Sinizzo is located east of the inhabited area of San Demetrio ne' Vestini (Fig. 3). Circular in plan view, the lake has an average diameter of approximately 120 m. The slopes around the lake are very steep at the southern and the eastern margin, where a sub-vertical ridge is present. From the latter, medium-sized rock falls detached as a consequence of the 6 April 2009 earthquake (Fig. 4). The affected slope consists of alternations of gravel and conglomerate layers with intercalations of finer horizons. The differences in the physical characters of the materials determine selective erosion in correspondence of the less resistant horizons, which cause some conglomerate, more compact layers, to overhang and occasionally fall, as experienced during the 6 April 2009 earthquake.

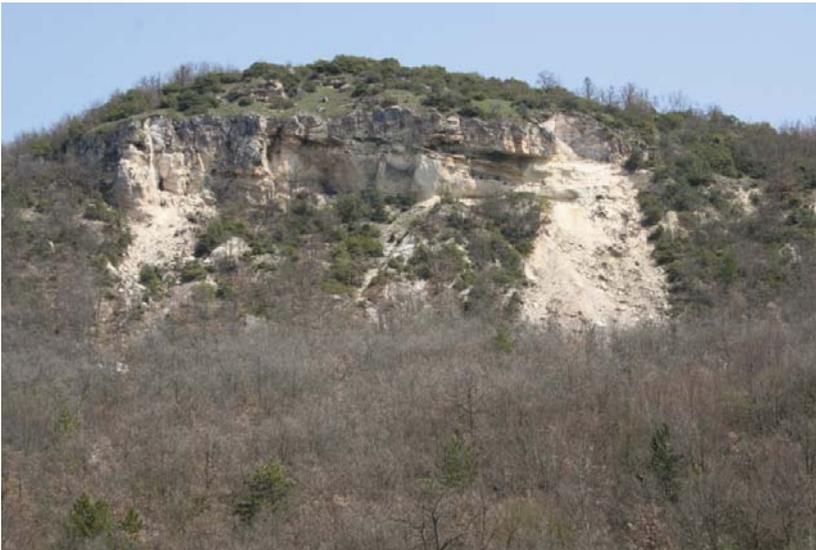
Fig. 4 – Rock falls triggered by the April 6, 2009, earthquake at the eastern slope of the lake, and the deriving debris talus. Note the two main source areas, corresponding to a conglomerate layer overhanging because of selective erosion in the underlying finer materials.

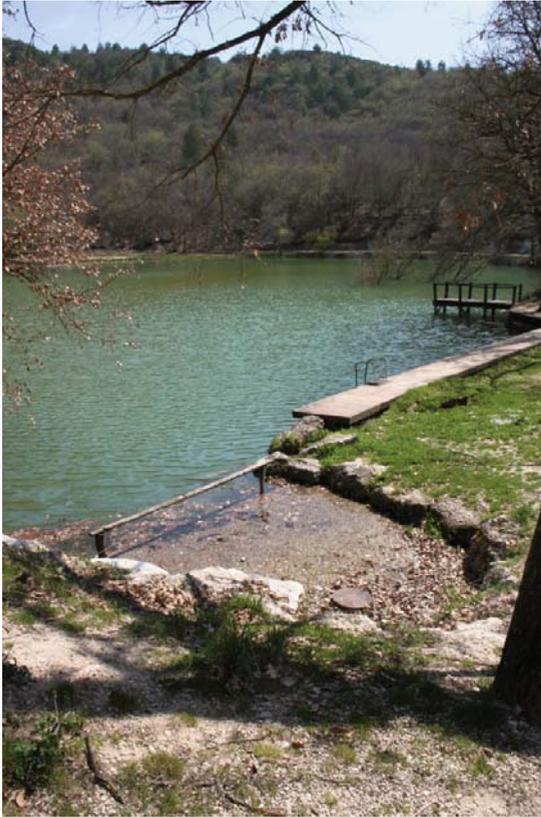
Fig. 5 – North-western corner of the lake, showing the man-made outlet realized after the impounding embankment.

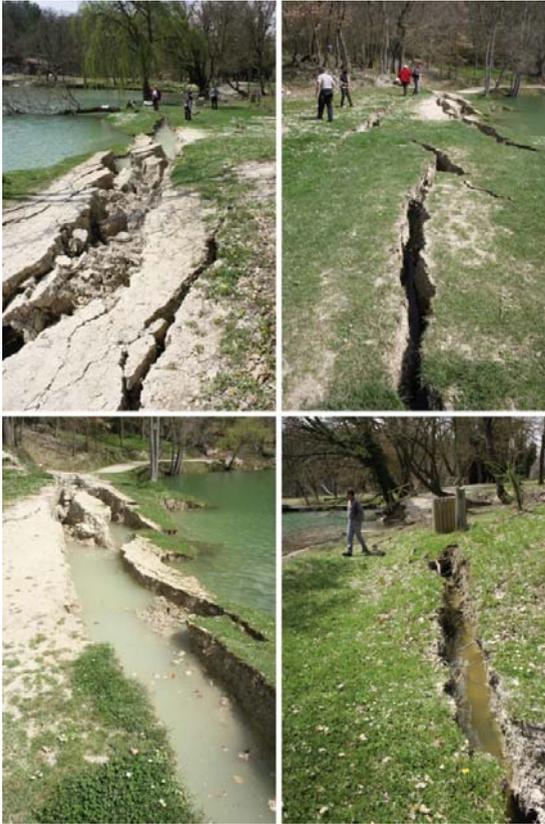
Fig. 6 - Pictures showing the cracks developed after the seismic shocks along the lake shorelines.

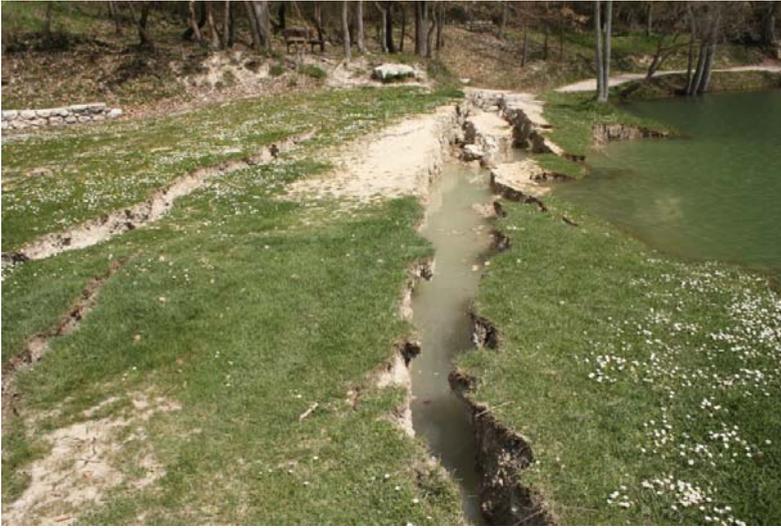
Fig. 7 - Sets of cracks dislocating the shore on the northern margin of the lake.

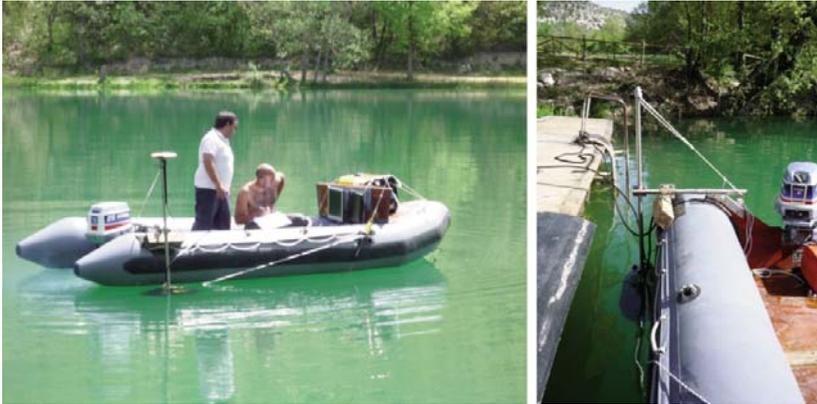
Fig. 12 - The rubber boat "Bombo" equipped with the 8101 multibeam system.

Multi-beam bathymetric data were collected from a rubber boat equipped with a dedicated pole and flange used to operate the sonar head (Fig. 12). Vessel tracks were positioned so as to insonify 100 percent of the lake floor, with significant overlap (Fig. 13). Patch test to determine and correct biases from positioning time delay (latency), pitch offset, azimuthal (yaw) offset and roll offset were performed after system installation in accordance with standard procedures. Multi-beam data were edited to eliminate spurious bathymetric and navigation points, and processed using PDS 2000 software from Reson. Subsequently, the processed data were used to generate a digital elevation model (DEM) with cell size of 5 cm x 5 cm, with an accuracy meeting the requirements of the International Hydrographic Organization (IHO).

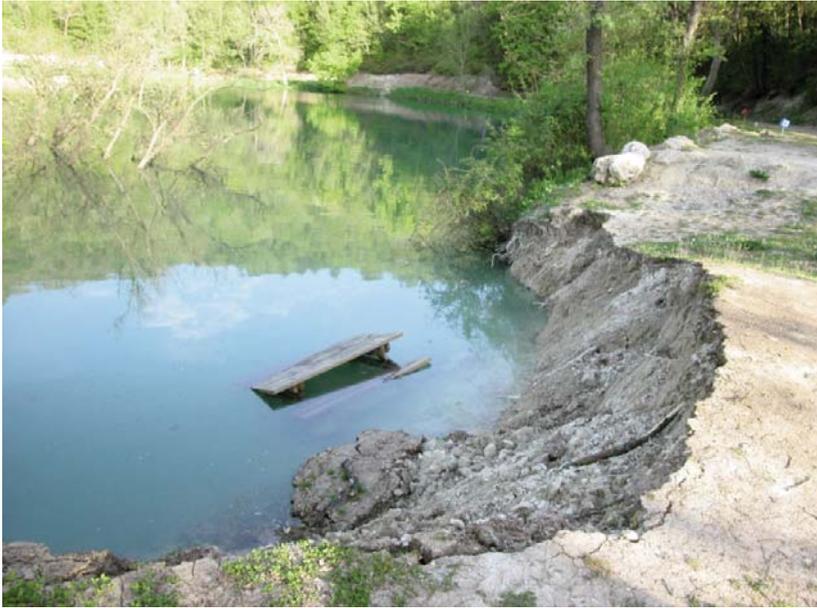
Fig. 17 – Failure of the lake shore occurred soon after the main shock. Note the displaced picnic table in the foreground and the submerged trees in the background.
